IP Office - Job Aid

Upgrading IP Office Software

This document looks at various IP Office upgrade processes. These are; upgrading IP Office applications, upgrading IP Office Control Unit and expansion unit software; and upgrading 4600 Series IP telephone software.

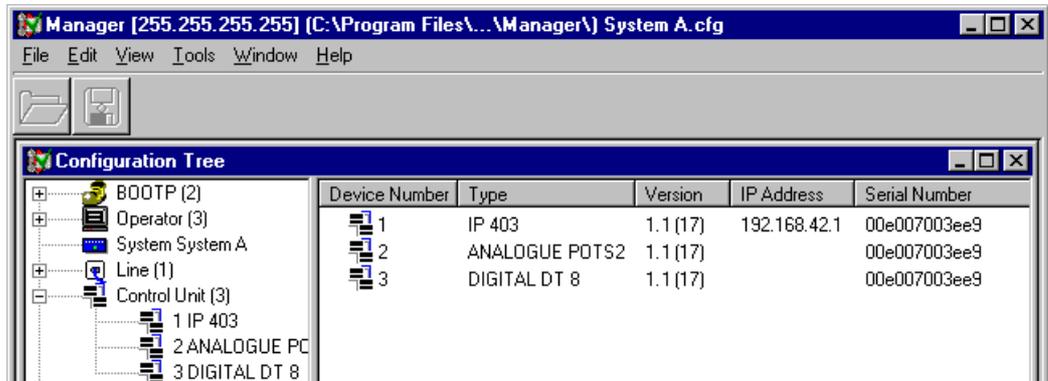
**Control Unit** to display a list of units in the system.

- b. Device Number 1 is the Control Unit (ie. **IP401**, **IP403**, **IP406** or **IP412**). Note its type, software version, IP address and the serial number. The Serial Number is the Control Unit's MAC address.
- c. Click on

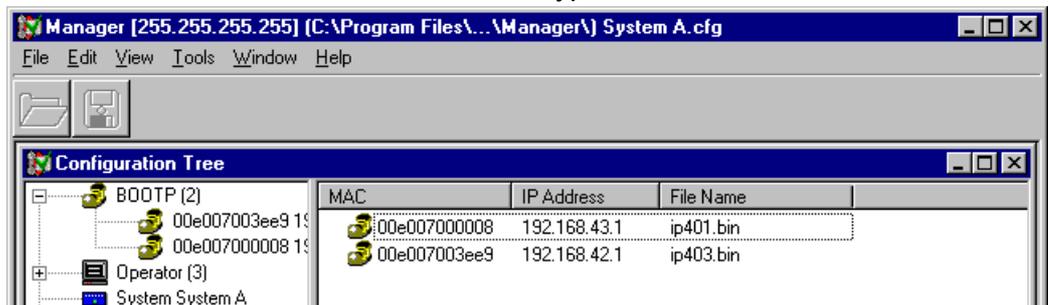
**BOOTP** to display a list of BOOTP entries. There should be one for every IP Office ever configured from the Manager PC. Check that the list includes the MAC and IP address of the Control Unit you want to upgrade and that the .bin file listed matches the Control Unit's type.

- d. If an entry does not exist right-click on the displayed list and select **New**. Enter the required details and click on **OK**. You do not need to send the configuration back to the IP Office as BOOTP entries are stored on the Manager PC.
- e. **Double-check the entry as this is a critical setting for the upgrade process.**

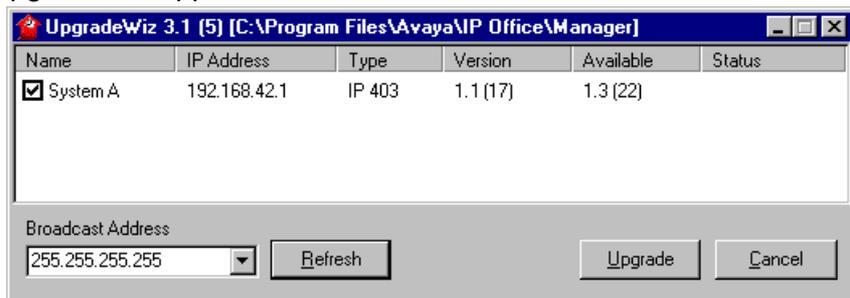
1. Ensure that you have followed the Pre-Upgrade Checks. See page 6.
2. Ensure that you have received and made a copy of the IP Office's configuration. If the upgrade fails the current configuration may be erased so a backup copy is an essential precaution.
3. In Manager, select **File | Advanced | Upgrade**. This starts the UpgradeWiz application.

4. After a few seconds the wizard should list the Control Units and Expansion Modules found.
 - **No Units Listed**
If this occurs using the **Broadcast Address** of **255.255.255.255** it implies that the Manager PC is not on the same LAN as the IP Office. You should not continue if this is the case.

5. The list shows the current software level of the units and the level of the appropriate bin file it has available for each unit from those in the Manager's working folder.

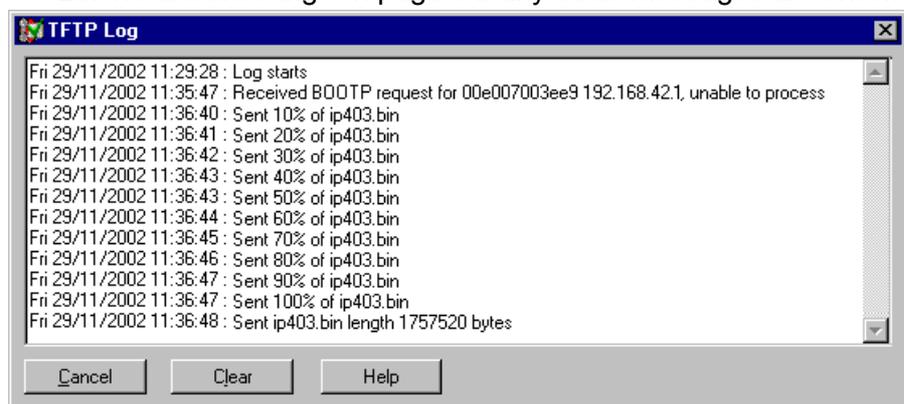
11. An example TFTP log for a successful upgrade is shown below. Refer to "2c. Troubleshooting" on page 9 if any other messages are shown.

Some clues as to the cause may be given by the entries in the TFTP Log that was running during the upgrade process.
